*Published in Pipelines 2005
Proceedings of the Conference
American Society of Civil Engineers
Held August 21-24, 2005
Houston, Texas*

Structural Rehabilitation of Cast-In-Place Concrete Sewers

Abstract

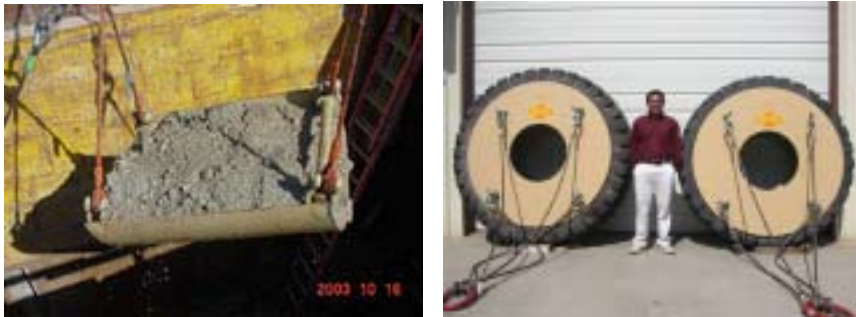
Figure 1. Cleaning bucket and tire swabs.

Cleaning. The three principal stages of cleaning of large diameter pipes are 1) removing loose debris from the invert, 2) removing loosely bonded deposits from the pipe wall and 3) removing more tightly bonded deposits and hydrogen sulfide induced concrete corrosion products (principally from the upper regions of the pipe wall). Smaller volumes of invert debris can be removed by high-pressure water flushing to a manhole followed by either vacuum or mechanical removal from the pipe. The level of debris in the invert of the Sims pipes required dragging a specially designed bucket, shaped to match the pipe invert, through the pipe to effect mechanical removal of the bulk of debris. The second stage cleaning was accomplished by the innovative use of large construction equipment pneumatic tires as huge squeegees/swabs (see Figure 1). Hydroblasting (10,000 psi (69 MPa)) final stage cleaning removed all remaining material leaving only competent concrete. In the upper reaches of the pipe walls, where the H₂S corrosion was prominent, the surface is very rough with well-anchored large aggregate exposed (See Figure 2 and Figure 3).

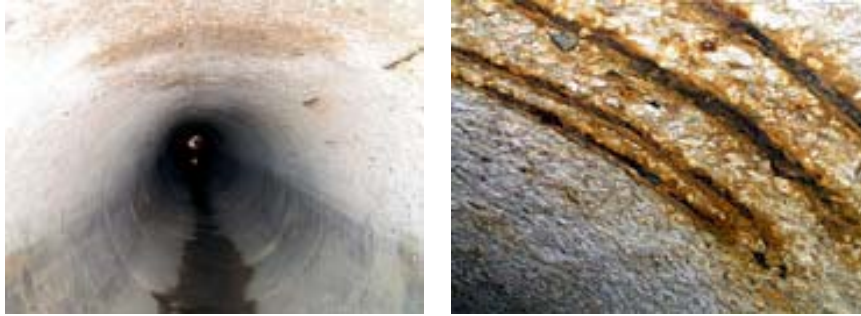
Figure 2. Host Pipe (after cleaning).

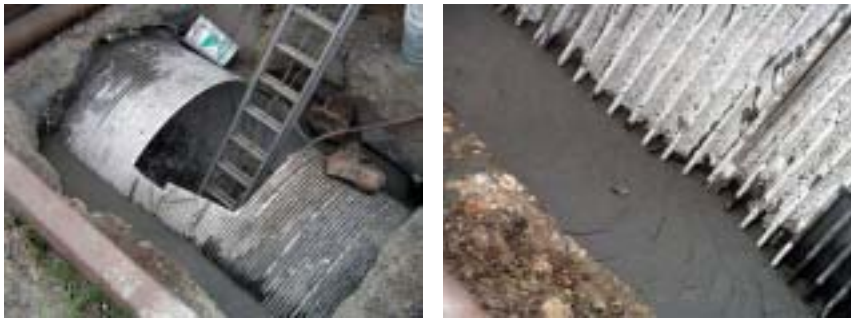
Figure 5. Partially grouted liner at 72" (1.83 m) to 78" (1.98 m) transition.

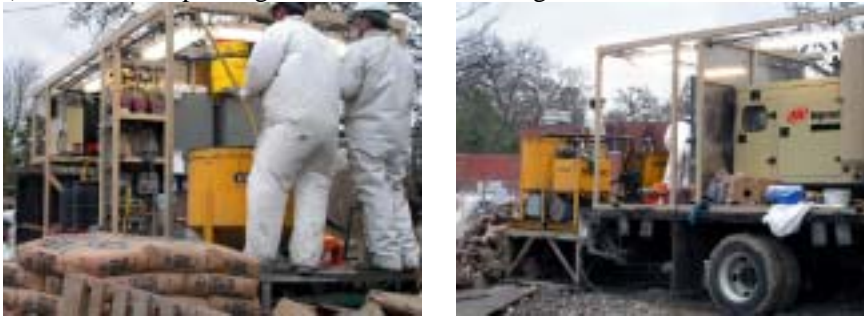
Figure 6. Mobile grout plant

Repeatability of grout mixes is greatly influenced by consistent addition of the proper amount of mix water and chemical admixtures and consistent mechanical mixing. Automation removes human errors and improves repeatability. The mobile grout plant employed on this project had programmable logic controlled metering of the mix water and chemical admixtures as well as the mixing time of the colloidal mixer. It was completely self sufficient with its own power sources, water and chemical admixture tanks and PLC meters, colloidal mixer, separate mixing and pumping hoppers. This grout plant (see Figure 6) produced as much as 20 CY (15 m³) of good quality grout in a single workday.
